REPAIRING ALUMINUM WIRING

Publication 516

ALUMINUM WIRING

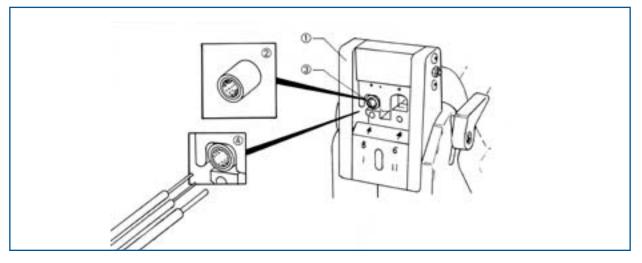
The COPALUM connector is a specially designed system that includes a metal sleeve intended to be installed only with a dedicated power tool and crimping die to make a permanent connection, that is, in effect, a cold weld (the precision dies in the CO-PALUM tool compress the connector and wires using upwards of 10,000 pounds of force, as required to make the permanent aluminum wire connection).

The tool is shown in the illustration below. An insulating sleeve is placed around the crimp connector to complete the repair. The copper wire pigtail is then connected to the switch, receptacle, or other termination device. An example of a repaired receptacle outlet is also illustrated below. Only electricians who are trained by the manufacturer to use the tool properly are authorized to install COPALUM connectors. CPSC staff emphasizes that this training is necessary to ensure that the electrician uses the careful, professional workmanship and thoroughness required to make the crimp connector repair safe and permanent.

COPALUM Crimp Connector and its Specialized Installation Tooling

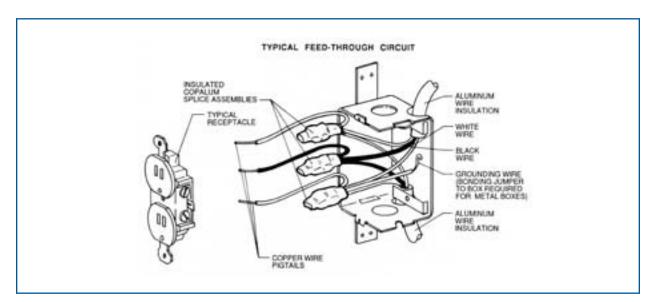
Recommended COPALUM Connector Repair

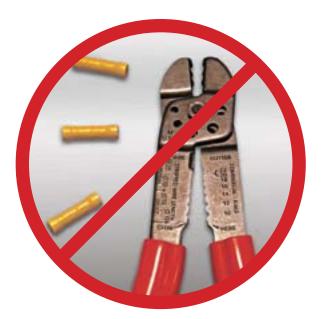
There are many other brands and types of crimp connectors — including those intended to be installed with a pliers-type of handtool — which are readily available to consumers at common retailers.

No other crimp connectors have been evaluated for connecting copper and aluminum conductors. CPSC staff strongly recommends against their use as a repair method.

Do Not Use Common Hand-Crimped Connectors with Aluminum Wire

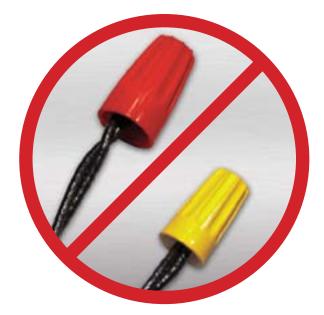
The first temporary repair involves pigtailing with a twist-on connector. The effectiveness of "pigtailing" using twist-on connectors has been evaluated by CPSC staff. In CPSC-sponsored laboratory testing and life tests, substantial numbers of these connectors overheated severely.

Surveys of and statements made by electricians and electrical inspectors confirm the highly variable and often poor performance of twist-on connectors with aluminum wire. It is possible that some pigtailing "repairs" made with twist-on connectors may be prone to even more failures than the original aluminum wire connectors. Accordingly, CPSC staff believes that this method of repair does not solve the problem of overheating present in aluminum-wired branch circuits.

"Pigtailing" with Twist-on Connectors Is Not a Recommended Repair

AL/CU twist-on connector pigtails or CO/ALR devices may be used as an emergency, temporary repair for a failed aluminum termination. Should such a repair be performed, CPSC staff recommends that a complete repair of the aluminum-wired system be performed using the CPSCrecommended methods as soon as possible.
